# Lessons from a rigging

## Well-drilled junior sailors help save a mast

BY TOM ALLEY

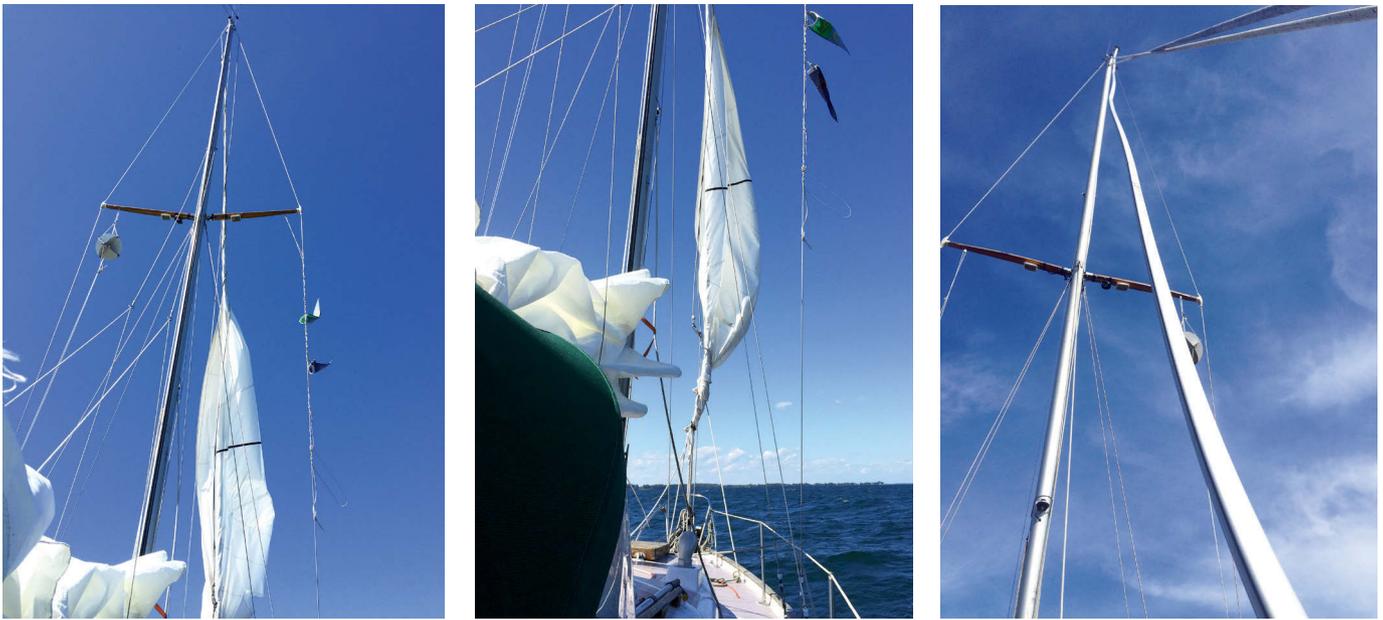
**Tomfoolery's crew was unable to completely snuff the foresail, at left, and it made motoring to windward impossible. Halyards rigged as jury headstays, center, kept the mast intact. Removing the foresail revealed the full extent of the damage to the furler, at right.**

It was a disheartening scene. It took almost an hour to unwrap the sail from the furler. Not one section of the furler foil had escaped damage. Each one had a twist, kink, or bend in it. At least one joint had sheared, resulting in the sail being wrapped not just in unequal amounts at different levels of the stay but also in opposite directions. The sail was ripped in several places and seriously stretched out in others.

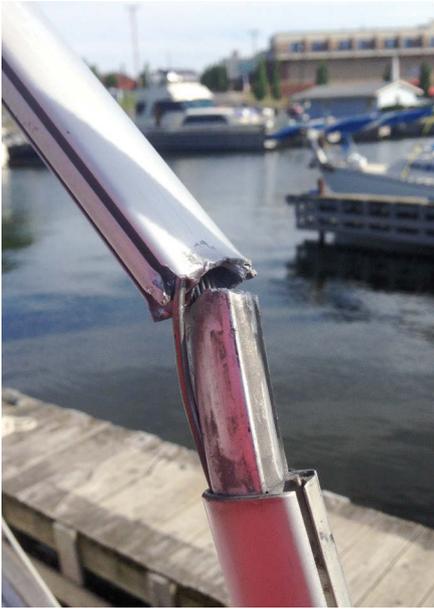
With the bottom of the forestay free, the sail, foil, and forestay then flew to leeward until stopped by the furling line, still attached to the boat. A sudden load on the furler (imposed by the repeated arrested momentum of the flogging sail) probably sheared the lower joint in the furler extrusion. At this point, the lower part of the sail started to furl as the furling line unwound, while the rest of the sail tried to unfurl, causing a number of stresses in the furler and in the sail. It's likely that the torsional loads on the extrusion, combined with the whipping action of the sail in the wind and the lack of support from a taut forestay, caused the damage to the furler's foil sections.

After the forestay parted, the violent flogging of the sail caused this joint between two sections of the furler extrusion to shear apart, at left. It was the lower clevis pin, the one that connected the forestay to the stem chainplate, that broke, center. A lucky find on deck was the piece of the clevis pin that sheared off, at right. An analysis of the pin allowed Tom to determine the possible cause of the failure.

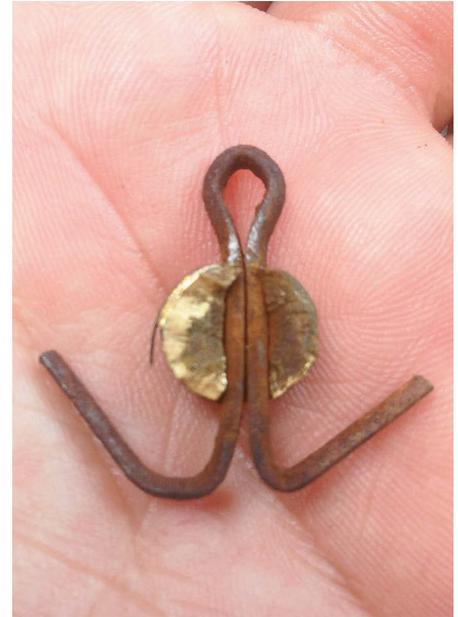
At first I believed the cause of the clevis pin failure was metal fatigue and that I had missed seeing a crack in the pin when I last inspected it. I assumed the staining on the fracture face was due to cotter pin corrosion leaching into a crack. Metallurgical analysis of the fracture face proved otherwise. In fact, it produced a number of surprises.

First of all, it was not metal fatigue but corrosion that caused the failure. As the corrosion propagated across the pin, its structural strength lessened until it could no longer support the load and failed.

Second, the corrosion started on the inside of the clevis pin, in the hole for the cotter pin. This means the corrosion was invisible from the outside of the pin. This is why I didn't notice it when I last inspected the rigging. Note the detail of the fracture face in the photo. The darker (corroded) areas are on the inside and the outer surface has bits of bright (uncorroded) metal on it.

Finally, the composition of the pin was not bronze as I'd believed it to be. In fact, the pin is a composition not typical of any marine alloy. It is 44 percent nickel, 32 percent copper, 18 percent zinc, and 5 percent chromium.

So it appears that, aside from metal fatigue and corrosion, sailors have yet another thing to worry about, and that is whether the supplier of clevis pins is reputable. This pin came with the boat when I purchased it, so I don't know where it came from. I purchased all new pins from a known supplier and they are all marine-grade stainless steel.

I sent one of the new pins to my corporate resource for analysis and confirmed that it really is type 316 stainless steel. But type 316 stainless steel is not immune to the crevice corrosion that can lead to this kind of failure. Crevice corrosion is not always visible even with a magnifying glass, and that is a good reason to replace this kind of hardware at intervals appropriate to the waters where a boat is sailed. Don't be like me and wait for a component failure to be your signal to replace hardware!

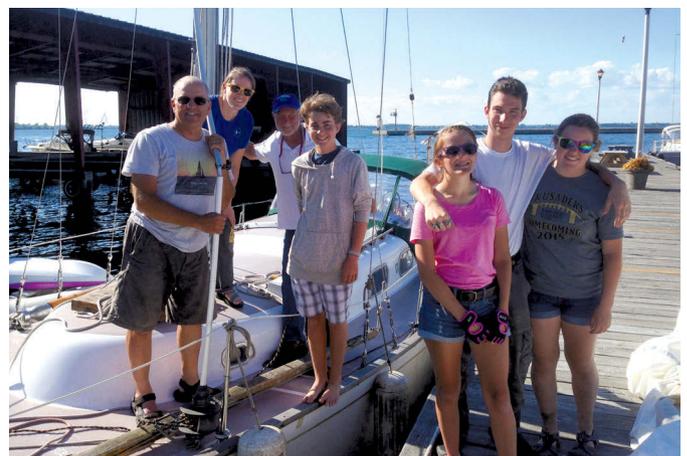
The "I Survived Lake Ontario" party was, from left to right, Captain Tom, Coach Andrea, Captain Mike, and junior sailors Henry, Katie, Isaac, and Maggie. Tom is holding the furling unit, which turned out to be totally destroyed. The genoa (lying on the dock) went into critical care at a local sailmaker to see if it was salvageable.

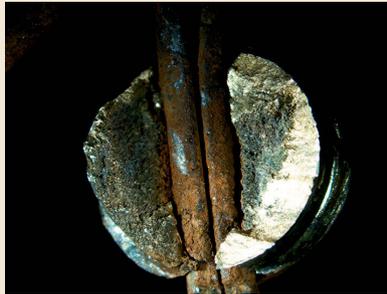
My first reaction on seeing Tom's photo of the broken clevis pin was that I was looking at a tensile fracture in a brittle metal. The granular appearance of the break is typical. I had seen this years before in the "let's break stuff" lab when I was studying engineering. Some years later, I witnessed its effect when a halyard winch came off the mast in my crew's hands when he was hoisting the genoa. The winch had been attached with no insulating barrier between its bronze base and the aluminum mast. Corrosion on the aluminum built up to the degree that it forced the winch base away from the mast, stretching the bolts to their breaking point.

In Tom's case, the rusted cotter pin is a clue. Even after the clevis pin broke and landed on the deck,

the cotter pin is still wedged in place, coated with rust. I surmise that this rust buildup initiated the fracture. The rusty color appears to extend into the granular areas of the broken clevis, suggesting the initial break was quite old. The shiny part of the break is where the pin finally sheared off under the sideways load from the sail in the bumpy conditions *Tomfoolery* encountered.

That the clevis pin was made of an alloy of copper and nickel, likely far more galvanically noble than the steel cotter pin, could be a contributory factor. That should only serve to emphasize the need to ensure all metal components on a boat are compatible, especially in critical systems like the rigging.

As to why such corrosion would appear on a freshwater boat, a rigging specialist I spoke to suggested that stray electrical currents might be at work, possibly as a result of aging wiring. Stray currents are hard to trace, but some of their effects can be paint bubbling around fittings on an aluminum mast, corrosion at the mast step, and corrosion in unexpected places — like a connection in the standing rigging.
