Chainplate restoration

One sailor's solution

by David Cowell

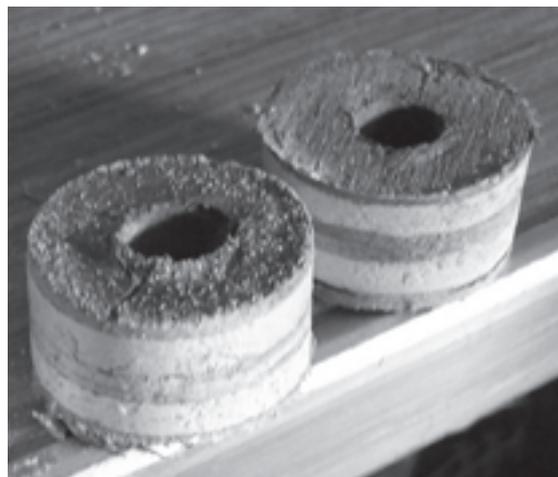
These bushing cores brought relief. The wood in the bore of the holes had been worked by repetitive forces but was not wet or damaged.

Inspection of the bulkhead holes showed no sign of rot. The wood in the bore of the holes was somewhat gray but not black. It had been worked by repetitive forces and had fatigued. What a relief! I wouldn't have to replace the bulkhead. I only had to repair the holes and reset the plates.

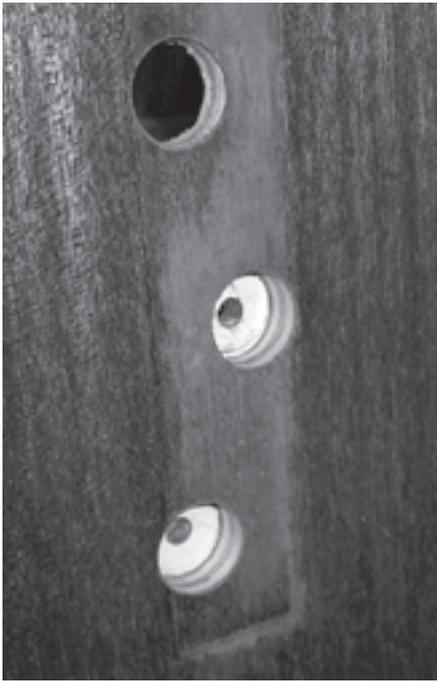
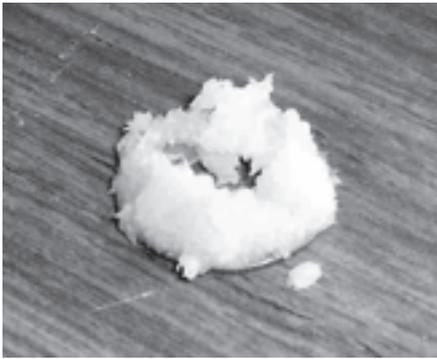
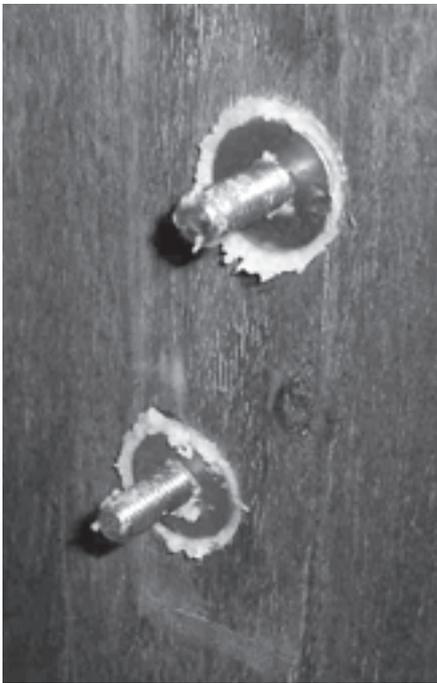
Chainplate holes drilled for bushings, top; a washer with epoxy ready for insertion, center; and a washer and epoxy packing, bottom.

My solution was to use stainless-steel washers and epoxy. The epoxy filled the void between the washers and the wood and bonded the washers and wood together. Once I had the concept, the technique was simple. I drilled out the deformed holes to a size just larger than the washers so they would be a close fit and concentric with the original hole.

I determined how many washers were needed by stacking them to the same thickness as the plugs I had cut out. Holding a bolt in place with a fender washer and some duct tape, I buttered a stainless-steel washer with epoxy and filler and put it into the hole. I continued to add buttered

washers to create a washer sandwich. In this state, the sandwich was thicker than the bulkhead. I placed another stainless fender washer over the end and tightened the whole with a nut, compressing the sandwich into the bulkhead. This pressure squished the epoxy out into the void around the washers, filling it. Since hydraulic pressure is equal all around, the epoxy flowed everywhere, including into the porous wood.

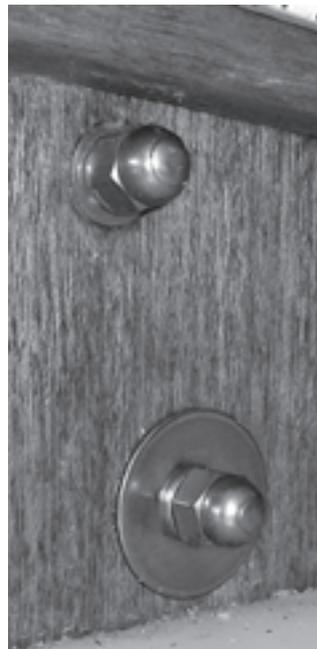
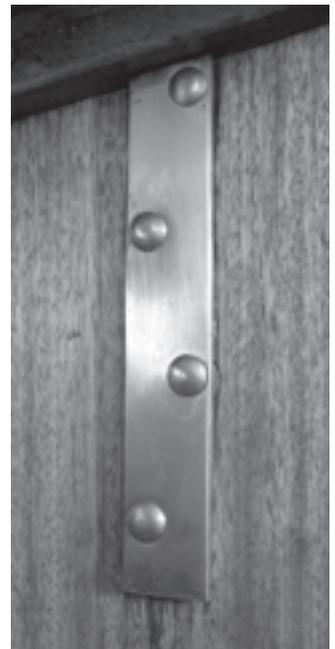
Chainplate backing washers, at right; the finished repaired chainplates, far right.

After the epoxy has cured, the chainplate can be bolted in its original position. It then must be sealed at the deck joint. I used 3M 4200 for this, as it forms a flexible bond to the metal and the gelcoat of the deck. The shrouds can then be installed and tensioned as needed.
