# Lessons from a rigging

## Well-drilled junior sailors help save a mast

BY TOM ALLEY

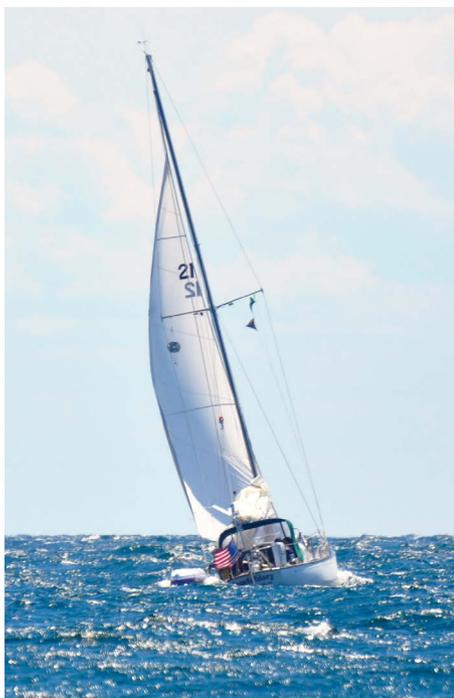
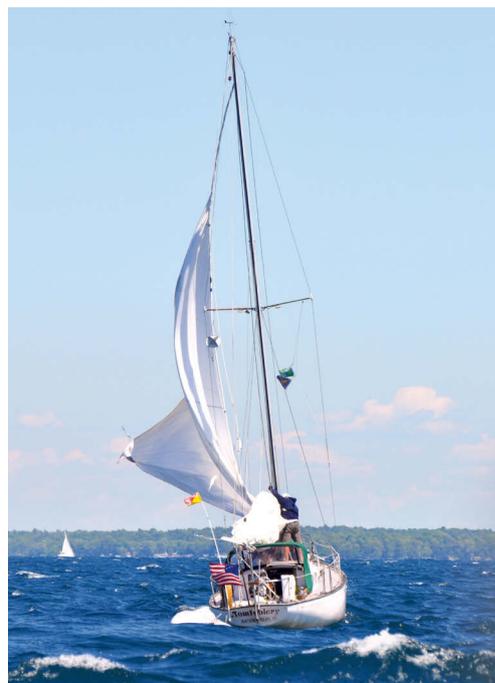
Shortly before the forestay let go, *Tomfoolery* was making good progress on starboard tack under a reefed foresail, at left. The failure prompted immediate action on board, below, but *Tomfoolery* was now exposed to a lee shore on Grenadier Island.
